| 1. AGENCY USE ONLY (Leave blank) | 2. REPORT DATE | 3. REPORT TY | REPORT TYPE AND DATES COVERED | |
|--|---|---|---|--|
| Charge state of Ge-related | G N0014-93-1-0777 | | | |
| M. E. Zvanut | | | | |
| University of Alabama at 1 | NUMBER: | | | |

Charge State of Ge-Related Point Defects in Oxidized SiGe Alloys

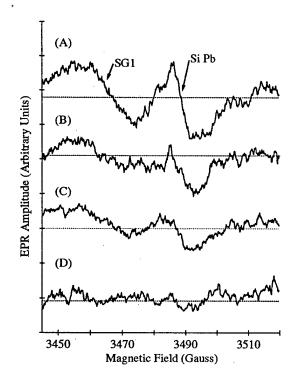
Figure 1. EPR spectra obtained after:

- (A) growth of 40 nm anchor oxide
- (B) 15 min KOH etch
- (C) 20 min KOH and 2.75 min HF etch
- (D) additional 90 min KOH etch

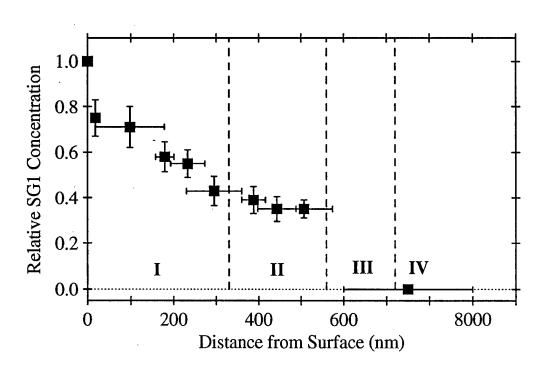
Figure 2. Depth profile for SG1 center; y-axis represents the original surface of the top SiGe layer. I, crystalline SiGe; II, buried oxide; III, damaged SiGe; IV, unimplanted SiGe
